ADEQUACY OF THE ARCHITECTURAL DESIGN OF A MULTIFAMILY BUILDING LOCATED IN CAMPO MOURAO-PR, TO FIT THE CONDITIONS OF ACCESSIBILITY.

The study was carried out based on the Philadelphia Residential Building project, under permit no. 677/2012, which is being built on Rua São Paulo, central region of the city of Campo Mourão

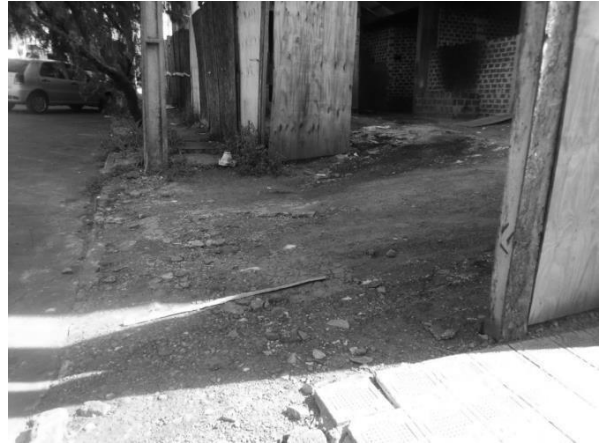
Figure 3: (A) Vehicle entrance to the building; (B) Front sidewalk of the building.

In figure 3A you can see the lack of paving, making it difficult for anyone to pass, whatever their motor condition. In the section in figure 3B, it can be seen that there was pavement, but it was not properly maintained and vegetation ended up taking over the area. This is because the work has not yet reached the stage of reconstructing the external floor, which makes it impossible to use the checklist in this part of the project.

As the details of this paving are not foreseen in the project, what is recommended in the Decree must be followed.

a) The longitudinal slope must follow the grade of the road;

b) The transverse slope must be a maximum of 2%;

c) The walkway must be continuous, with no steps, ramps, differences in level of any nature or transversal strips that characterize an obstruction being permitted;

d) The adaptation of the sidewalk regarding accessibility for people with disabilities will be carried out through the implementation of a ramp built in accordance with ABNT – NBR 9050, at each intersection, and a pedestrian crossing with special treatment for circulation (tactile floor) must also be implemented. , at the discretion of the Planning Secretariat

Furthermore, as it is included within the area established in the decree as Standard “A”, it must be built with an interlocking coating (Paver) with concrete block pressed at 35 Mpa, measuring 22x100x60mm, produced in accordance with the specifications of the NBR 9781 standard of

in light gray and graphite gray, ensuring tactile directional signaling strip for guidance for visually impaired people, in red, as determined by NBR 9050, which must be placed in accordance with the provisions of Annex X and specifications provided by the Planning Secretariat – SEPLA.
